Environment Agency

Mytholmroyd flood investigation

Independent review into the flood
event of 8/9 February 2020

REP/274242-20/001

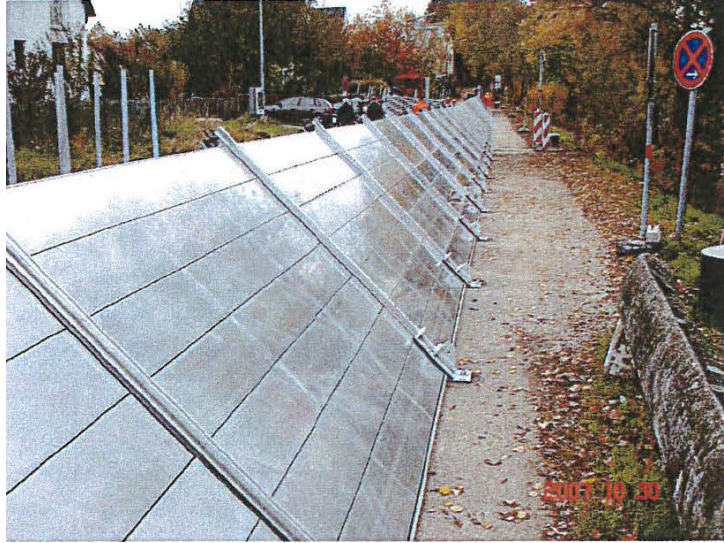
Figure 2: Typical installation of a K-Barrier System

2.4.1 The K-System barrier is a modular flood prevention system which can be extended and adapted to suit the local topography. This is shown in Figure 2 below.

- 2.4.2** The K-System barrier has a number of sections that make up a barrier and rubber seals are fitted to seal the gaps between them. In addition, specific corner pieces are used to tie the barriers into areas where a straight barrier is not sufficient. The pressure of the flood water pushes down on the surface of the barrier and the seals to form a watertight barrier.

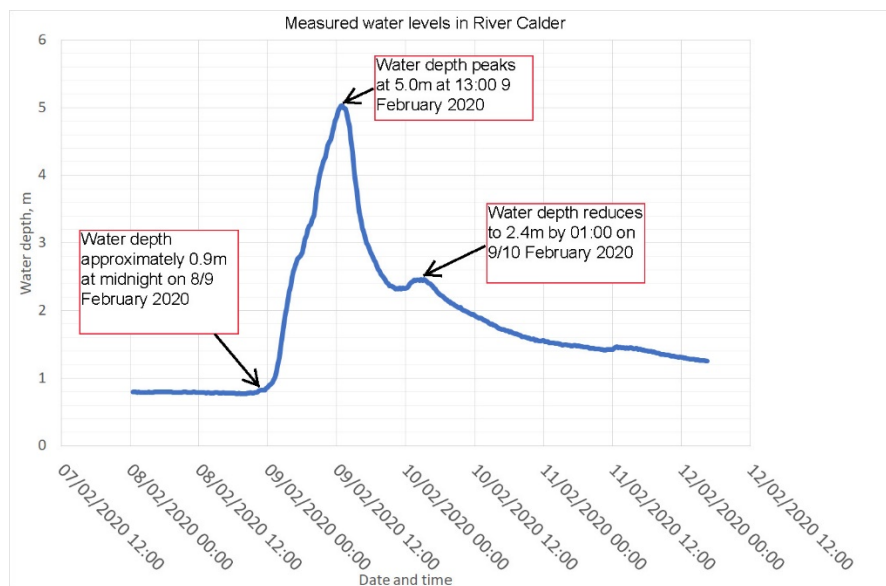
Figure 4: Time series data from Mytholmroyd temporary depth gauge

3.3.5 We have reviewed the water levels in the River Calder from data from the Mytholmroyd temporary depth gauge. As can be seen below in Figure 4, on 8 February 2020, the water depth in the river was approximately 0.9m. This rose to 5.03m between midnight and 13:00 on 9 February 2020. This was an increase of 4.2m in only 13 hours.

- 3.3.6** To place this flood event in context it was the second highest ever recorded, second only to the Boxing Day floods of 2015.
- 3.3.7** Analysis has shown that the 9 February 2020 event had a magnitude equivalent to a 1.33% (1 in 75) chance of occurring in any one year. This exceeds the design of the MFAS which was designed to better protect against a flood event of up to a 2% (1 in 50) chance of occurring in any one year.

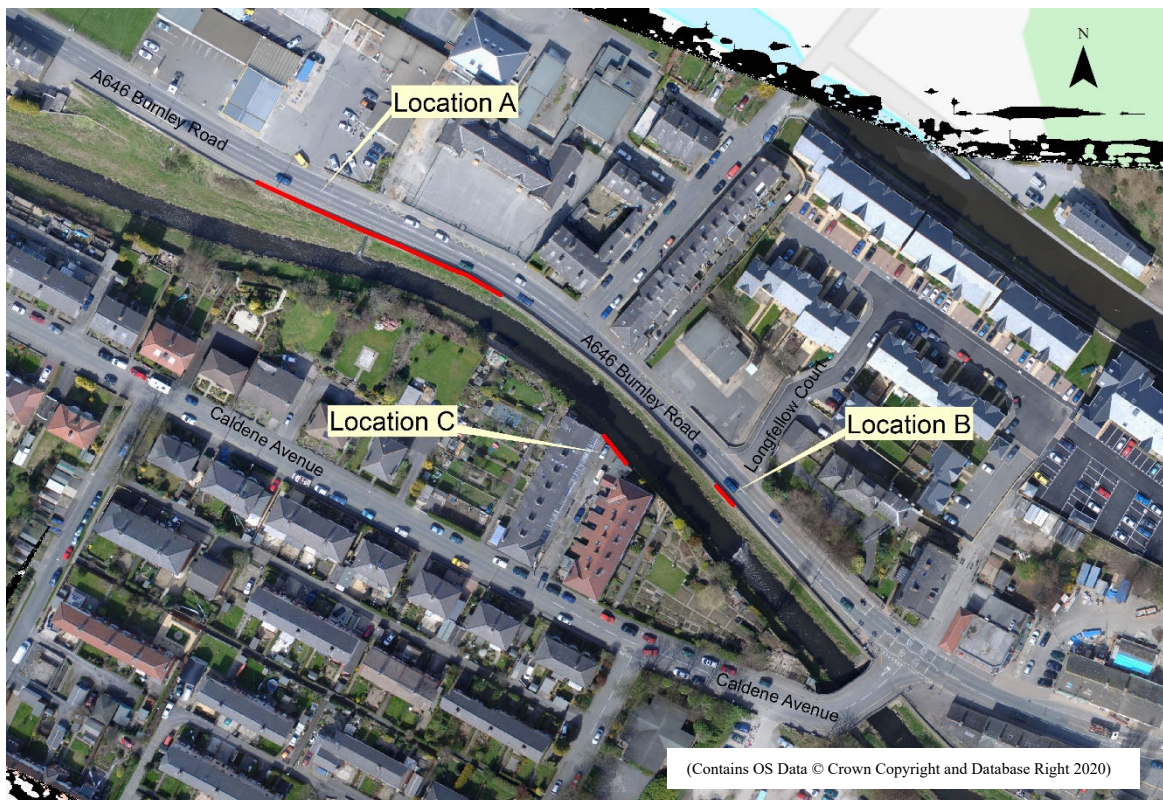
Figure 5: Location of temporary defences provided by the Contractor

4.1.3 Temporary defences comprised (see Appendix A and Figure 5 for locations):

- K-System barriers opposite Burnley Road Academy (Location A).
- Bulk bags opposite Longfellow Court (Location B).
- Bulk bags with polythene sheeting at Calder Grove (Location C).

- 4.2.1 When Storm Ciara arrived, the construction of the MFAS was partially completed and areas where the previous defences had been removed were replaced by temporary defences.
- 4.2.2 The Contractor deployed different types of temporary flood defences as outlined in paragraph 4.1.3 above. These temporary defences had to provide a flood defence level equal to that of the pre-MFAS level.
- 4.2.3 There were three specific areas where the Contractor deployed temporary defences to fill gaps in the incomplete MFAS defences. These were opposite Burnley Road Academy; opposite Longfellow Court on Burnley Road; and on the right bank adjacent to Calder Grove. These are referred to as Locations A, B and C respectively, as shown in Figure 5.

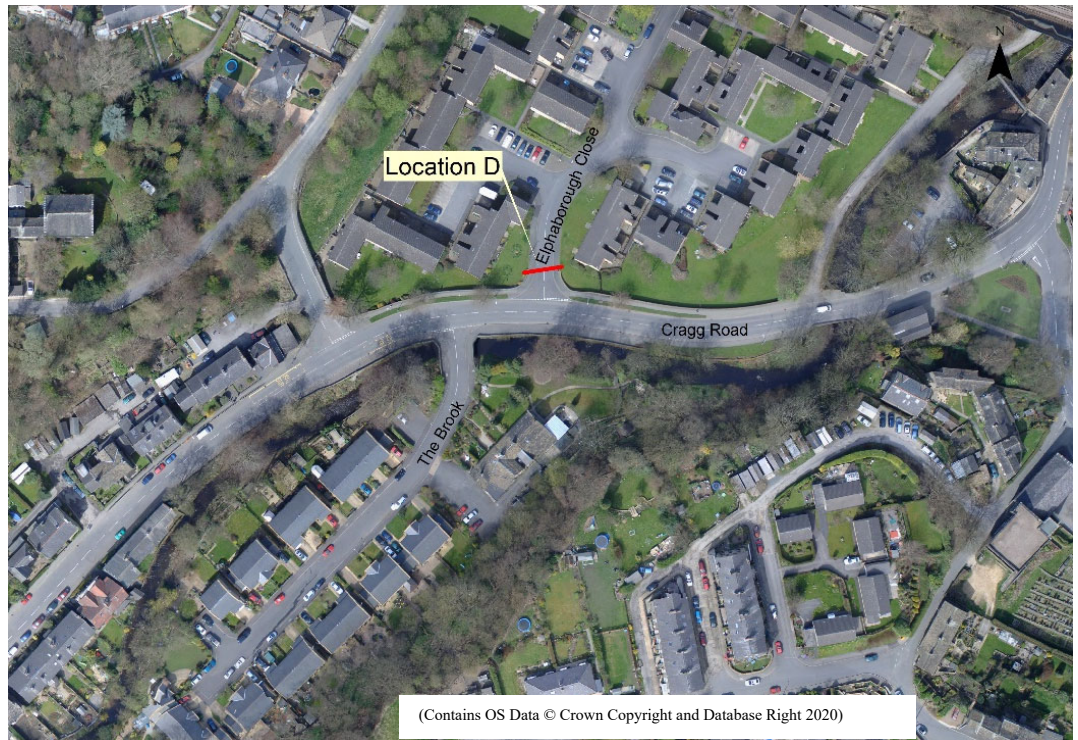
Figure 6: Location of temporary defences deployed by the Flood Wardens

- Flood wardens deployed temporary defences on Elphaborough Close (Location D shown in Figure 6 below).

- 4.3.1** Flood Wardens deployed temporary defences at the entrance to Elphaborough Close as shown in Figure 12 below. Elphaborough Close is situated just off Cragg Road and is situated on higher ground (see Figure 6). These defences were not associated with MFAS.

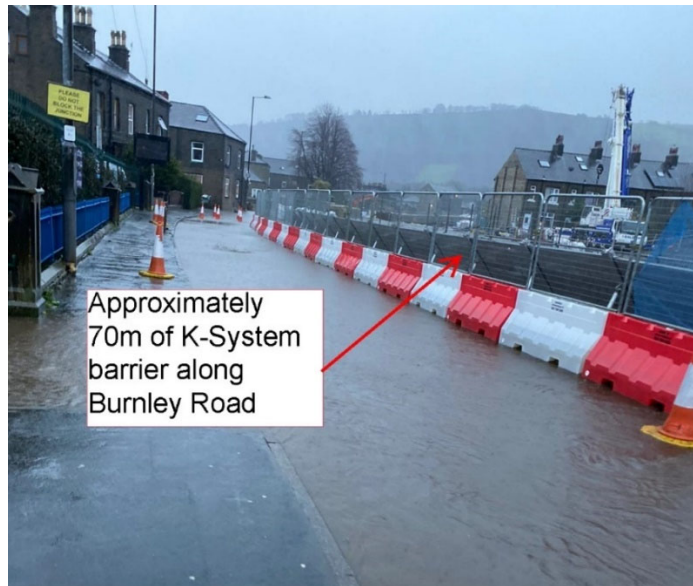
Figure 7: Photograph of K-System barrier on Burnley Road

- 4.2.4 This location had approximately 70m of K-System barriers placed parallel to the River Calder on Burnley Road. This is shown in Figure 7 below.

4.2.6 The height of the K-System barrier was 1.3m. Ground levels varied from 91.7mAOD at the downstream end to 92.3mAOD at the upstream end. This would mean that the top of the K-System barrier

was approximately 93.0mAOD at the downstream end to 93.6m at the upstream end.

4.2.7 We compared this to the pre-MFAS defences which were at a height of 93.0mAOD at the downstream end and 93.6mAOD at the upstream end.

4.2.8 Therefore, the K-System barrier height was the same as the pre-MFAS flood defences.

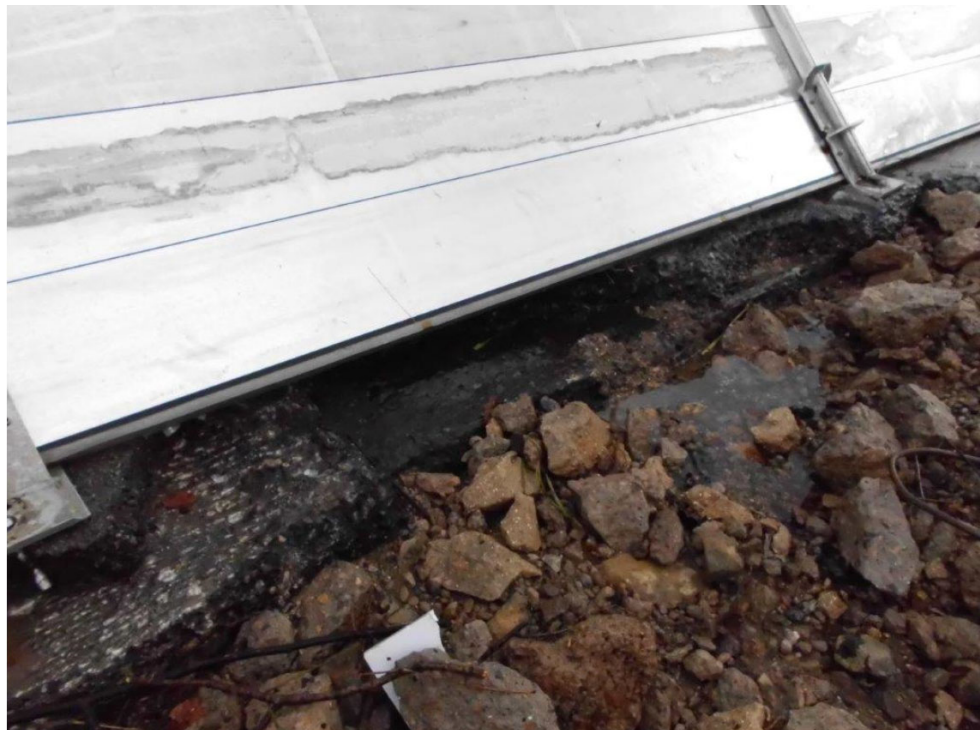
Figure 9: Photograph showing the exposed road edge and an area where the flood water has washed away tarmac and base material

4.2.9 We noted that where K-System barriers were located near to an exposed edge of road surface, there is evidence of material under the road surface being washed away by the flood water which caused the road layers to crumble and allowed water to pass under the barrier. Figure 9 and Figure 13 clearly shows this.

4.2.10 It is not clear from the evidence whether a check on ground unevenness was undertaken, if a ground seal was used or if any sandbags were used to fill low spots.

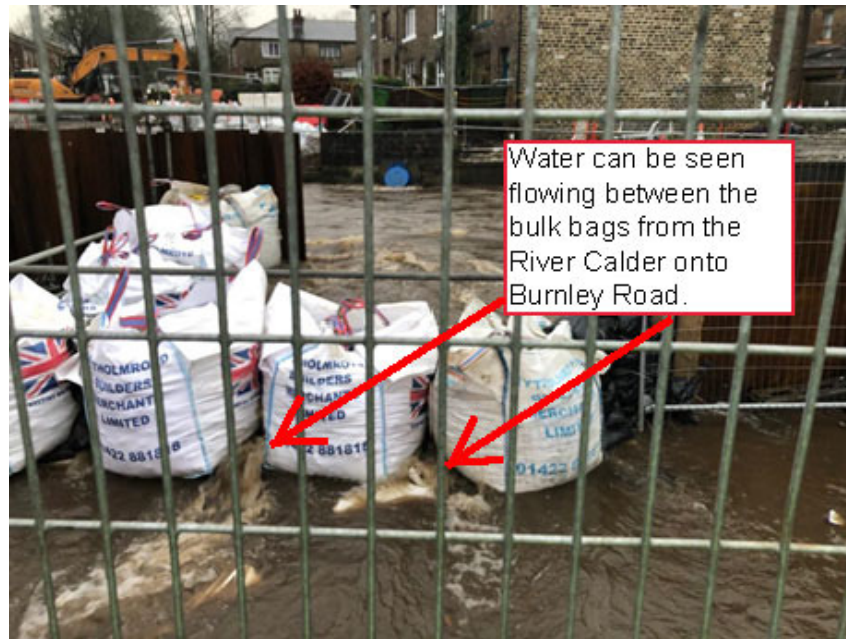
Figure 10: Image showing L-type arrangement of bulk bags

4.2.11 Location B is a small gap between two sections of wall which were still under construction. The temporary defences in Location B consisted of an L-type arrangement of bulk bags as shown in Figure 10 below.

- 4.2.12** Bulk bags are typically 0.9m wide, by 0.9m deep by 0.9m high. We have estimated the gap as being 4m wide. It does not appear that the bags at Location B on Burnley Road (Figure 10) filled this gap sufficiently. We can also see that the bags were not filled to their full height.
- 4.2.13** At Location B, ground levels are approximately 91.3-91.4mAOD and the pre-MFAS flood defence was 92.7mAOD.
- 4.2.14** This would mean at most the top of the bulk bag would be 92.3m AOD. The bulk bags were approximately 0.4m lower than the pre-MFAS flood defence.
- 4.2.15** This location is close to the Mytholmroyd temporary depth gauge which recorded a peak flood level of 93.25m AOD. This shows that the flood water would have overtopped these temporary defences.

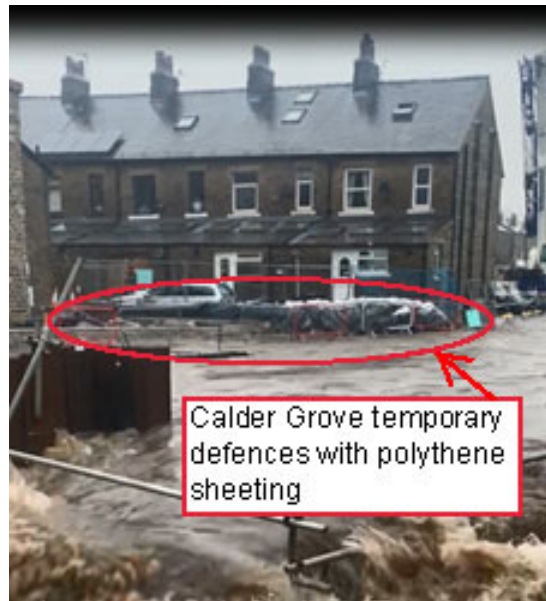
Figure 11: Snapshot of video showing bulk bags with polythene sheeting

- 4.2.16** Bulk bags were deployed as temporary flood defences at this location on the right bank of the River Calder (Caldene Avenue side) at the end of Calder Grove (see Figure 11 below). The bulk bags were covered with polythene sheeting.

- 4.2.17** There is no evidence of overtopping or water coming through these bulk bags at Calder Grove.

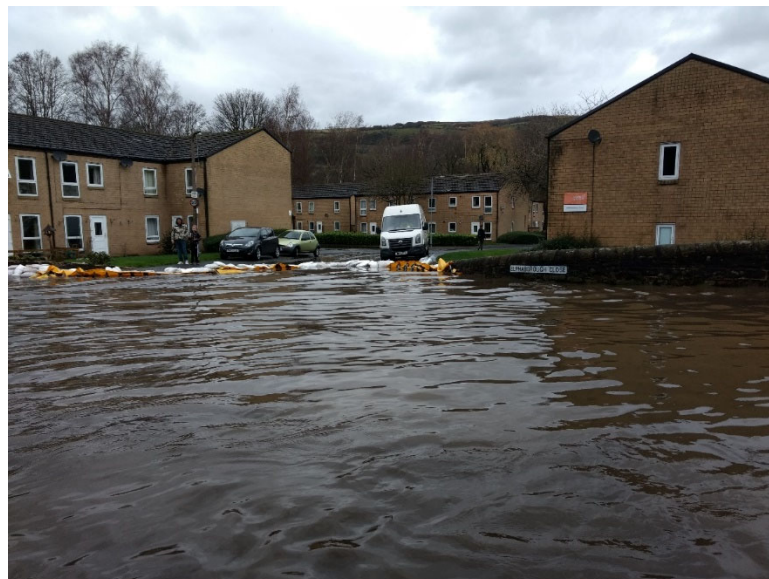
Figure 12: Temporary barrier at Elphaborough Close

- 4.3.2** We have received no evidence to show flooding on Elphaborough Close.

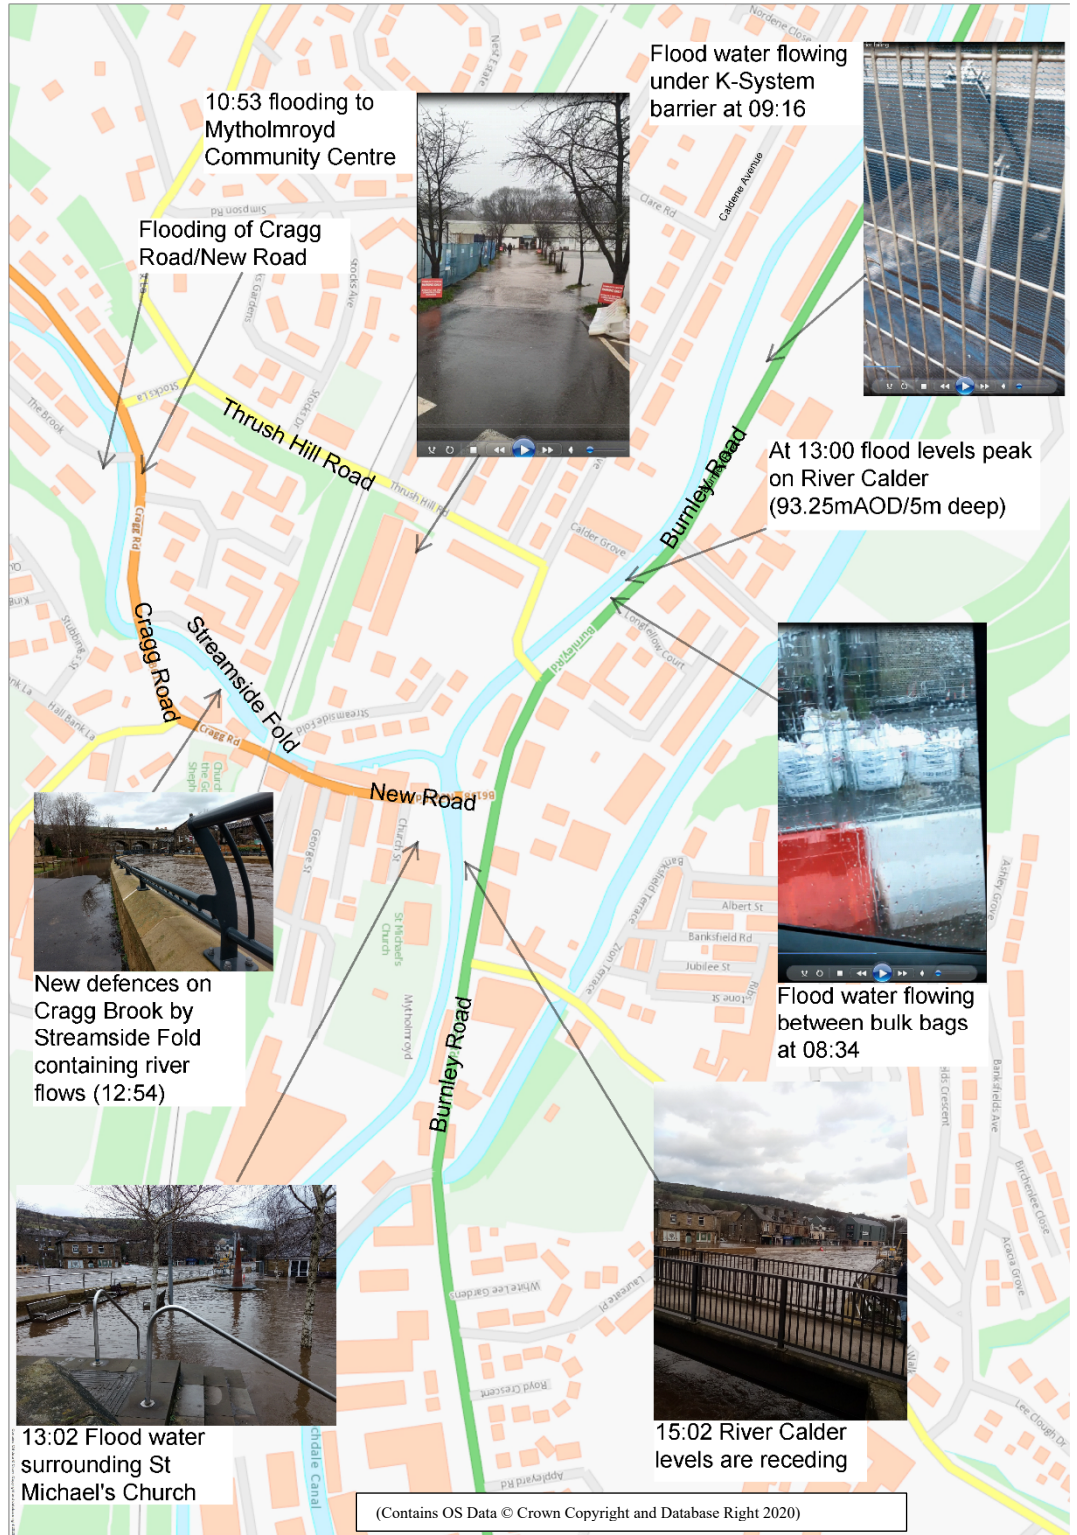
Figure 13: Photographs showing flooding and times in key locations

5.1.1 This section describes the timeline of flooding using the data sources listed in Section 2.5. Figure 13 is a map with photographs and video stills of key events.

5.1.2 Many of the photographs and videos were not time stamped, therefore it is possible some flooding happened earlier than indicated in the timeline.

throughout the flood. If they remained open these might have contributed to the flooding by allowing river water to enter onto Burnley Road.
09:16	River water can be seen coming under the K-System barrier at Location A.

09:17	River water is flowing under the bulk bags which were deployed at either end of the K-System barrier (Location A). The water level in the River Calder is lower than the top of the temporary defences demonstrating that the temporary barriers were not effective.

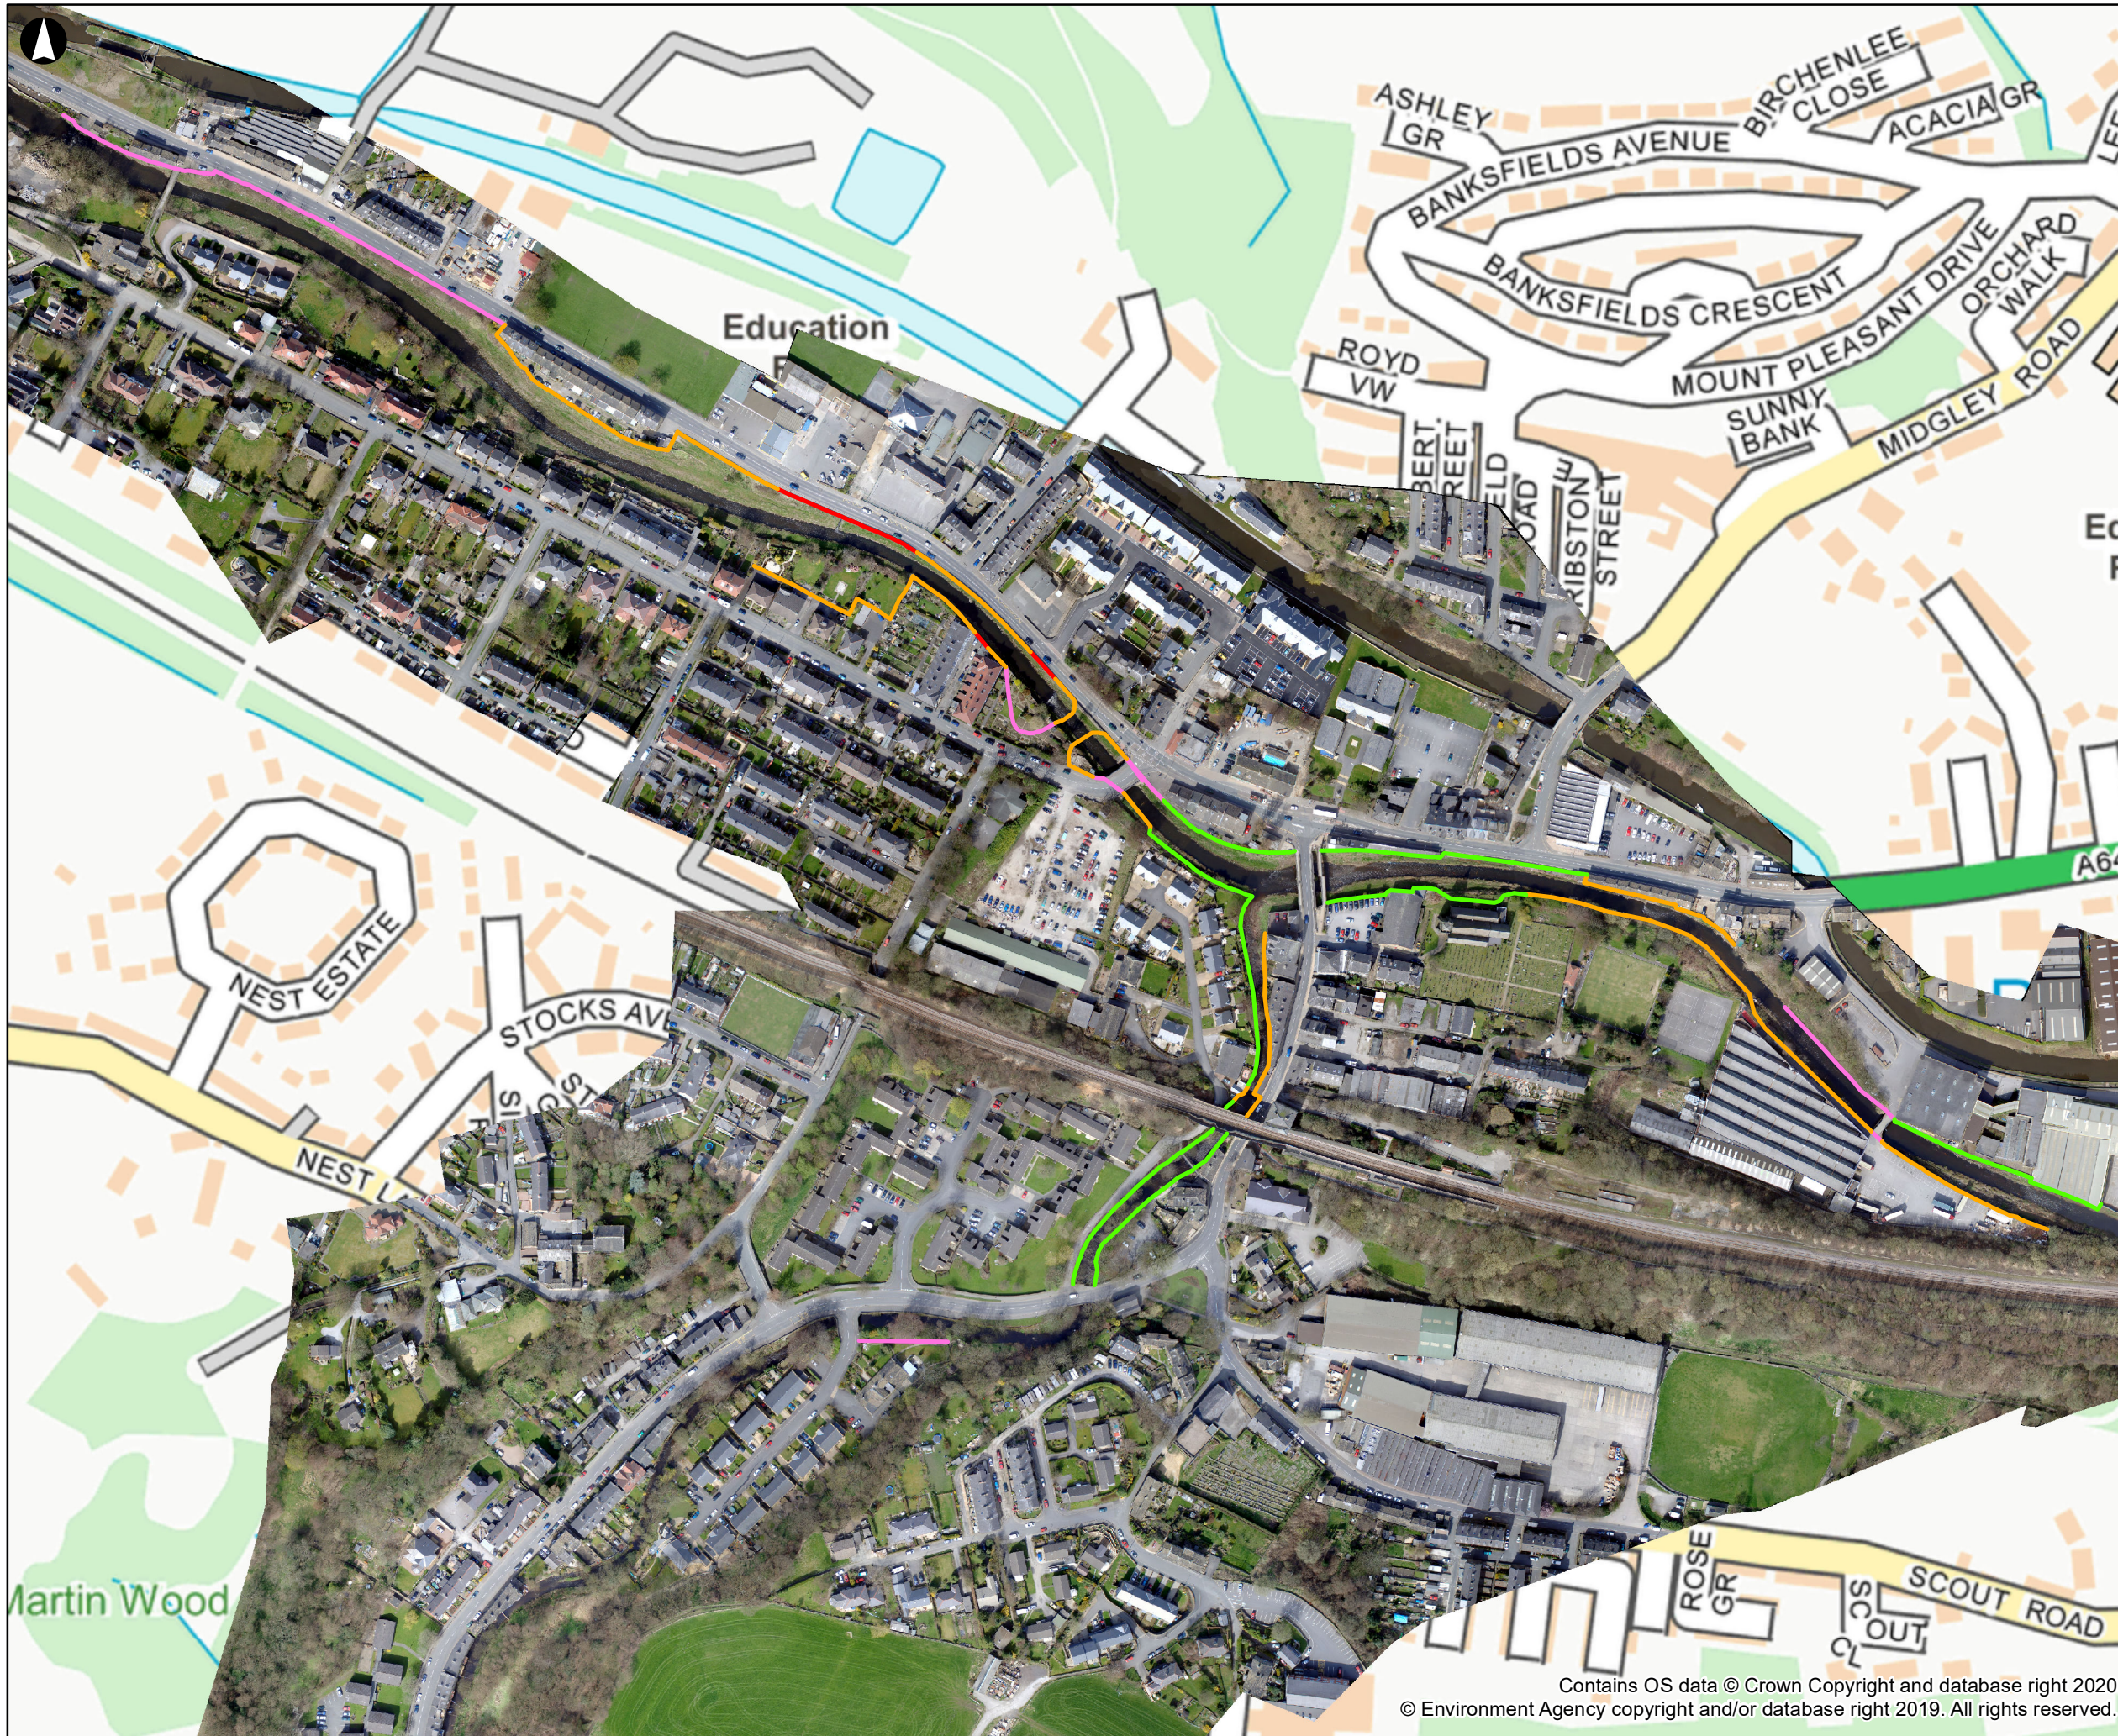
A1 Indicative location and progress of existing, temporary, partially completed and completed flood defences in Mytholmroyd on 9 February 2020

4.1.2 Permanent flood defences comprised (see Appendix A):

- Unaltered existing defences;
- MFAS defences under construction; and
- Newly completed MFAS defences.
